DAM SAFETY INSPECTION CHECKLIST

NAME OF DAM: Forestburgh Pond Dam

STATE ID #: 163-0135

INSPECTION DATE: February 27, 2020

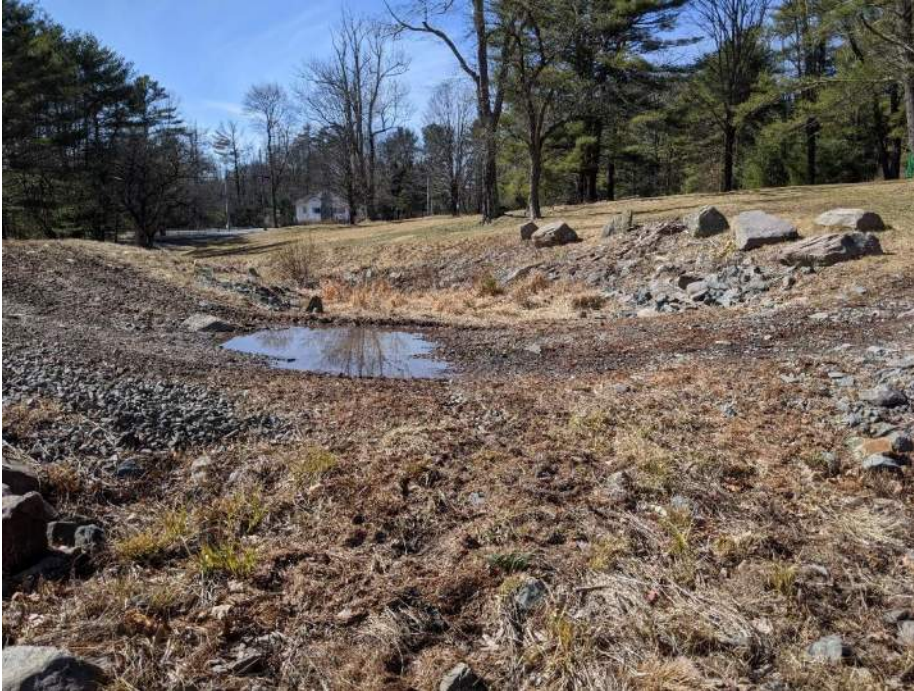
Photo No. 1

Location:
Beginning of Auxiliary
spillway

Subject:
Road built across spillway

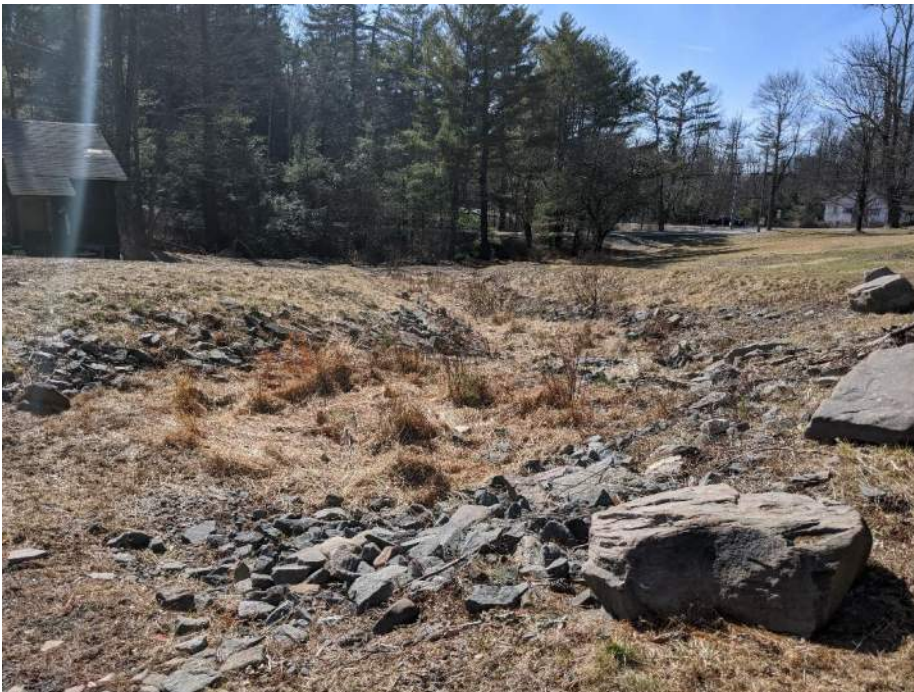
Photo No. 2

Location:
Auxiliary Spillway

Subject:
Downgradient View

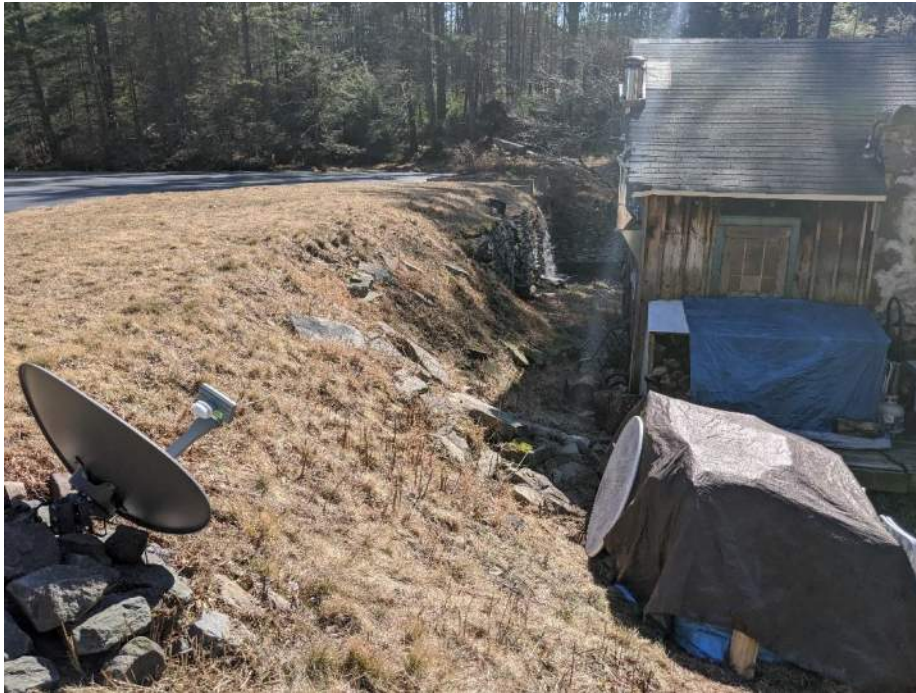
Photo No. 3

Location:
Northwest downstream face of dam

Subject:
View along downstream face

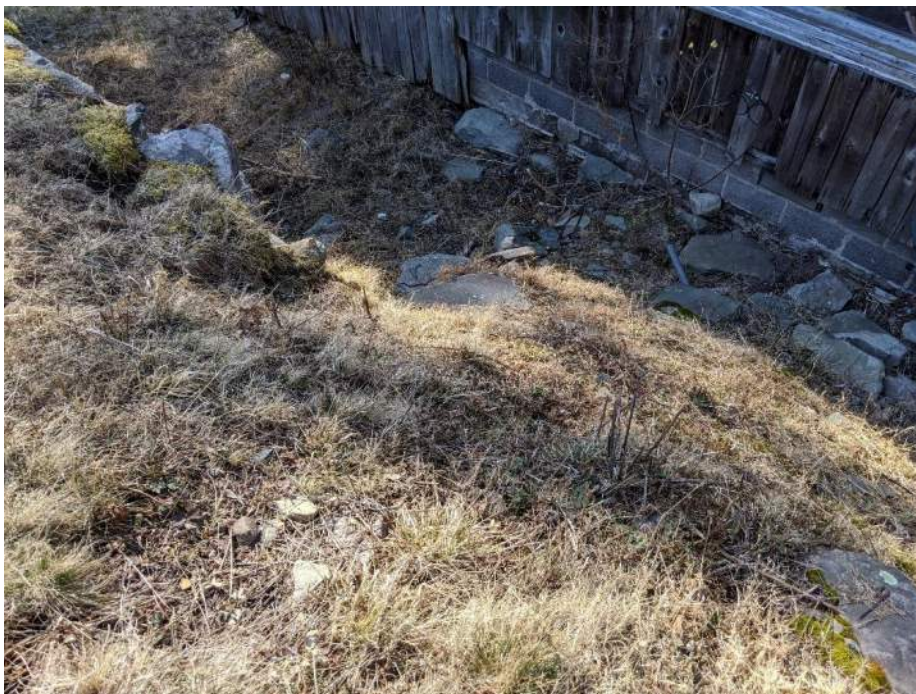
Photo No. 4

AREA INSPECTED	CONDITION	OBSERVATIONS	NO ACTION	MONITOR	REPAIR
D/S WALLS	1. WALL TYPE	Stacked stone (and earthen)		X	
	2. WALL ALIGNMENT	Movement noted several locations		X	
	3. WALL CONDITION	Fair		X	
	4. SEEPAGE OR LEAKAGE	None within the stone wall	X		
	5. EROSION/SINKHOLES BEHIND WALL	None observed	X		
	6. ANIMAL BURROWS	None observed	X		
	7. UNUSUAL MOVEMENT	Movement noted several locations		X	
	8. WET AREAS AT TOE OF WALL	On northside		X

Location:
Northwest downstream area

Subject:
Wet area at toe of dam

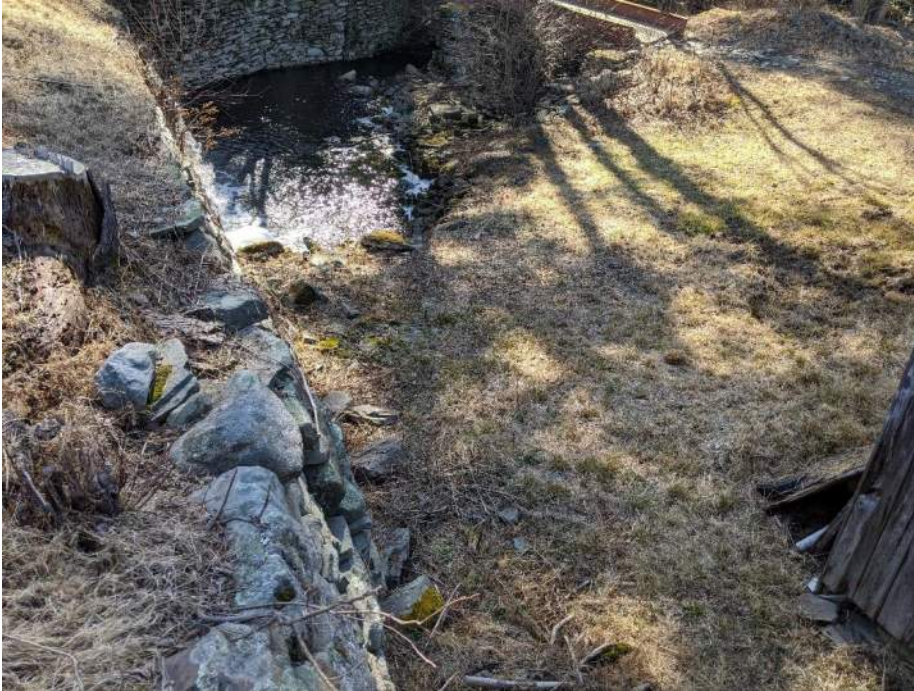
Photo No. 5

Location:
Downstream area adjacent
to outlet

Subject:
Wet area

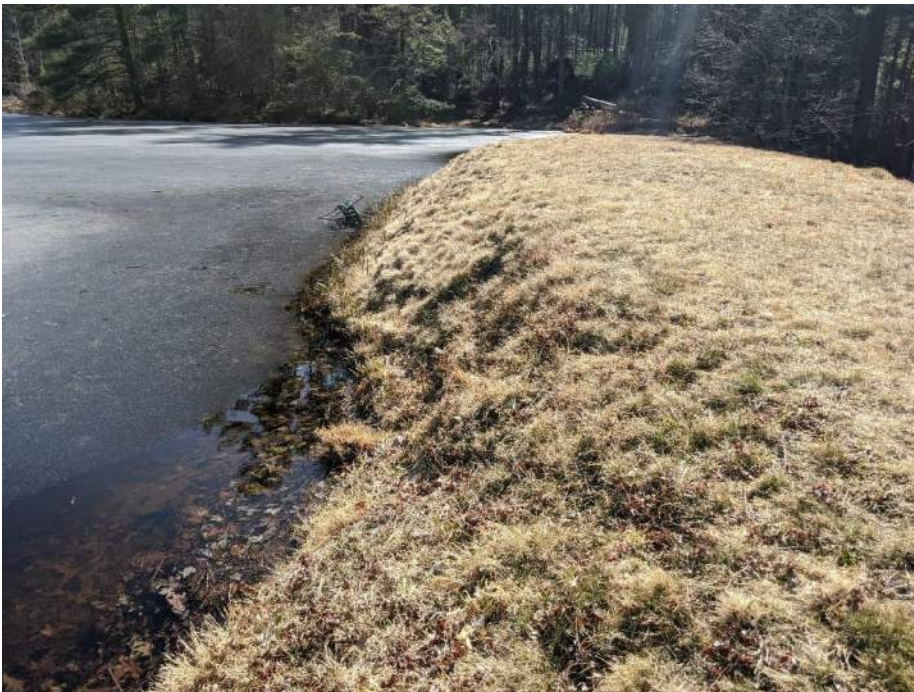
Photo No. 6

NAME OF DAM: <u>Forestburgh Pond Dam</u>		STATE ID #: <u>163-0135</u>			
INSPECTION DATE: <u>February 27, 2020</u>		NID ID #: <u>NY12761</u>			
EMBANKMENT (U/S SLOPE)					
AREA INSPECTED	CONDITION	OBSERVATIONS	NO ACTION	MONITOR	REPAIR
U/S SLOPE	1. SLIDE, SLOUGH, SCARP	Minor slough noted on north side		X	
	2. SLOPE PROTECTION TYPE AND COND.	sparse - monitor effectiveness		X	
	3. SINKHOLE/ANIMAL BURROWS	minor activity note (within vegetation only)		X	
	4. VEGETATION (PRESENCE/CONDITION)	Present and well established	X		
	5. EROSION	None observed	X		
	6. UNUSUAL MOVEMENT	Minor movement noted northside (across from old tree stump)		X	
ADDITIONAL COMMENTS: _____ _____ _____ _____ _____ _____ _____

Location:
North side of dam, upstream
side

Subject:
Minor Slough

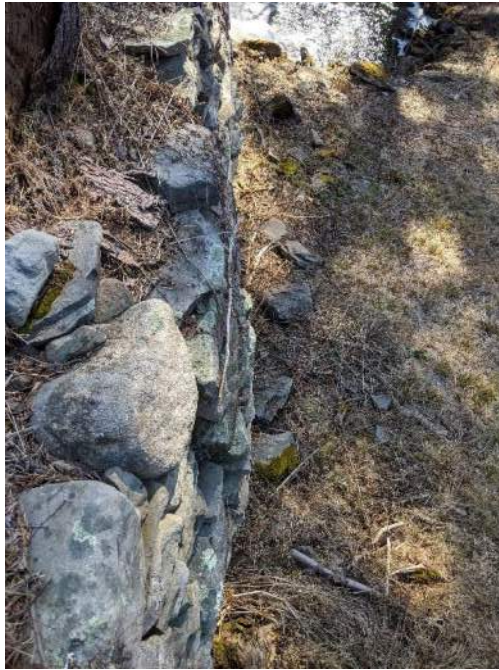
Photo No. 7

Location:
 North downstream face of dam

Subject:
 Outward movement of stacked stone dam wall

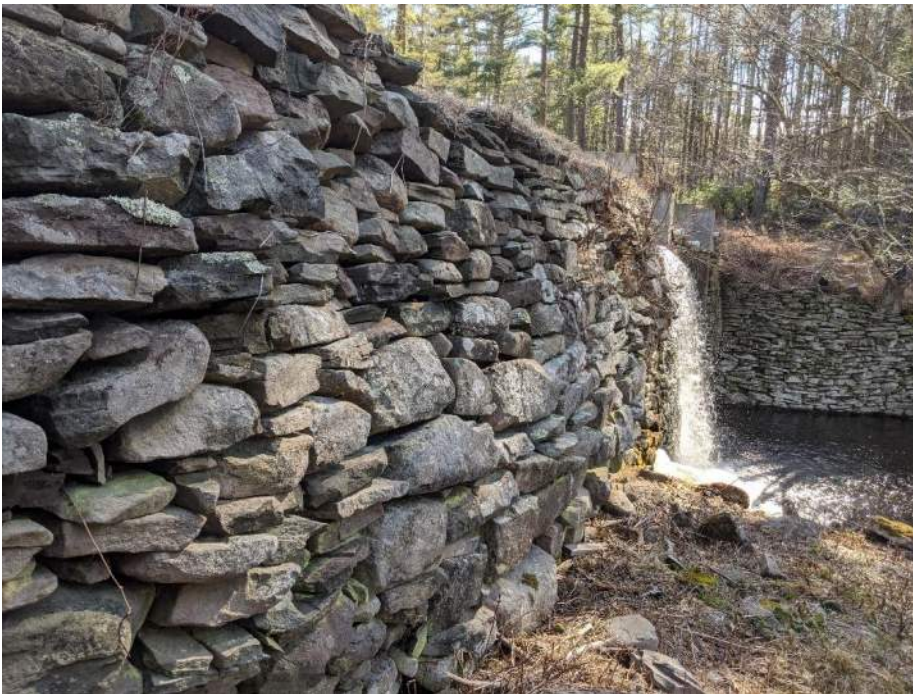
Photo No. 8

Location:
 North downstream face of dam

Subject:
 Outward movement of stacked stone dam wall

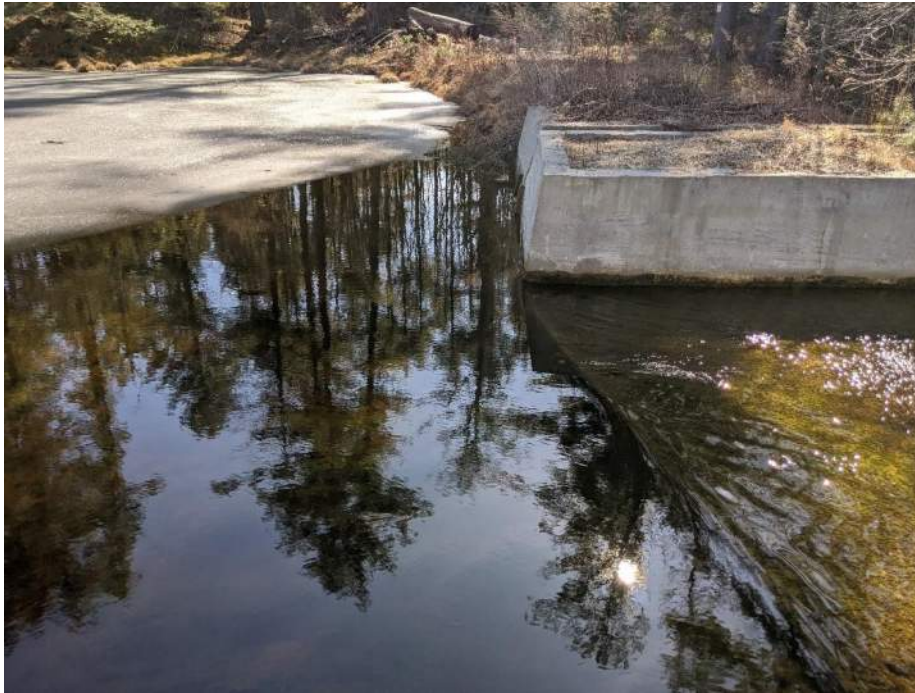
Photo No. 9

Location:
Primary Spillway

Subject:
Crack in south training wall

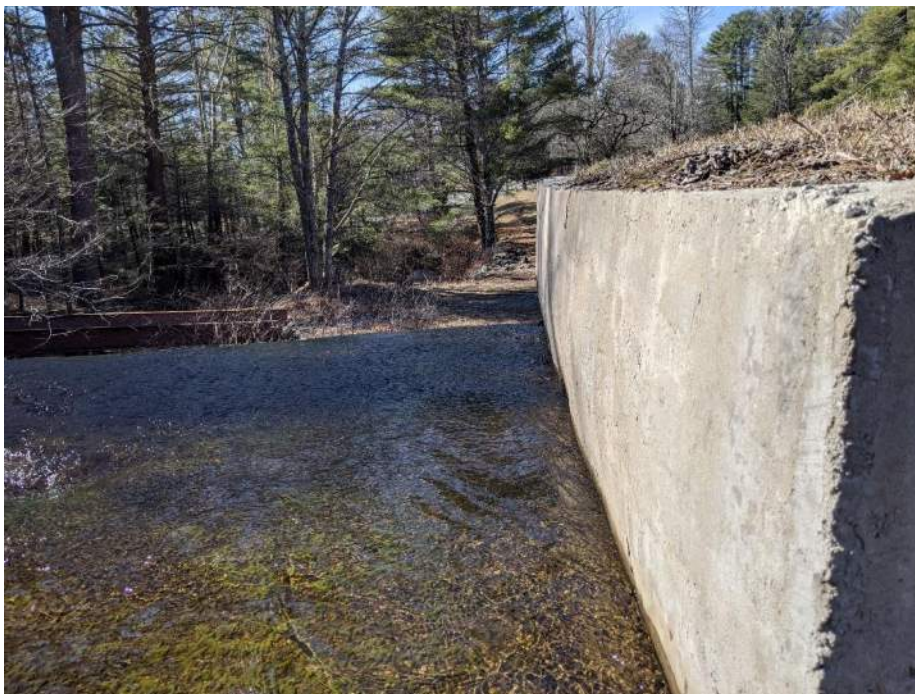
Photo No. 10

Location:
Primary Spillway

Subject:
Outward movement in north training wall

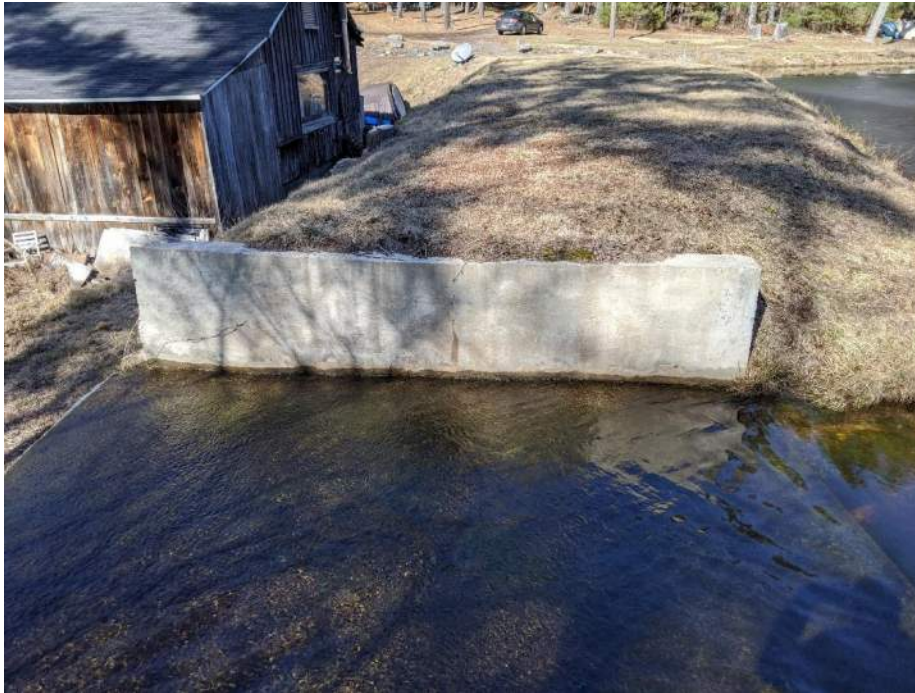
Photo No. 11

Location:
Primary Spillway

Subject:
Crack in north training wall

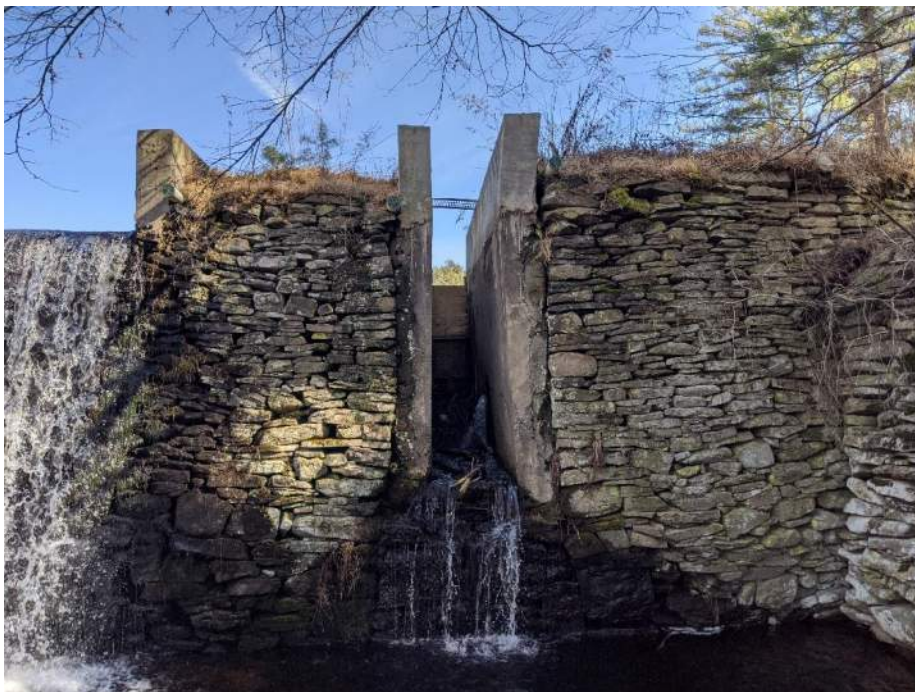
Photo No. 12

Location:
Downstream area

Subject:
Leak in low level outlet,
movement in low level outlet
walls.

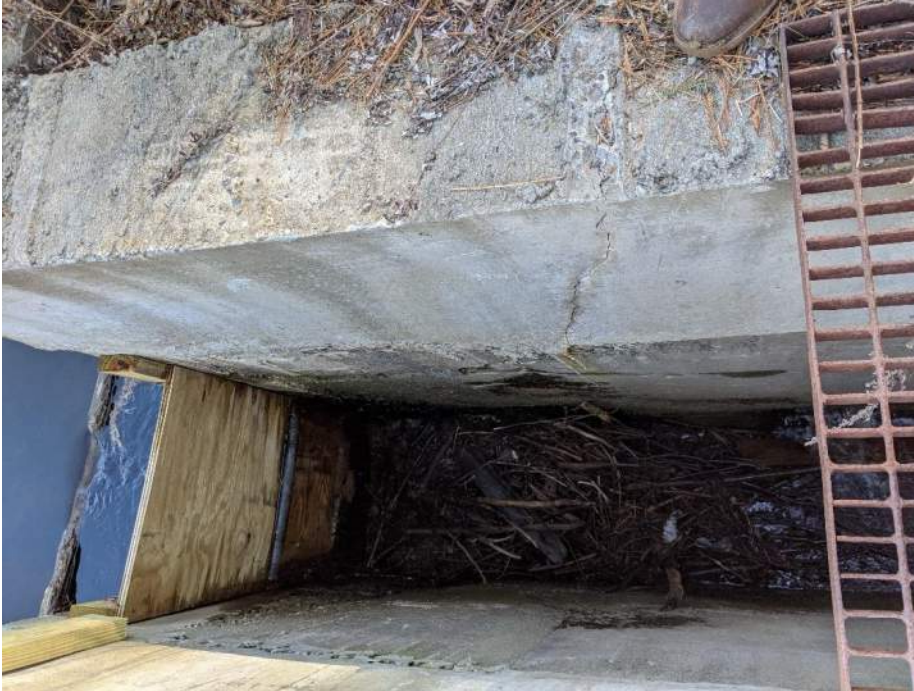
Photo No. 13

Low level outlet

Leak in concrete wall, wood

weir not secured and leaking

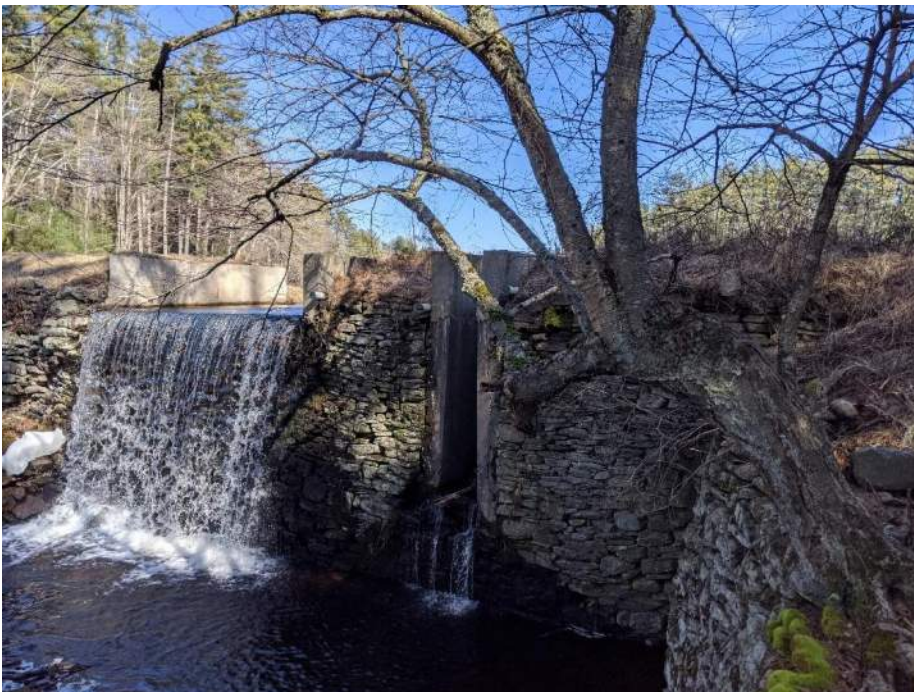
Photo No. 14

Downstream area

Tree growing on south

embankment wall

ADDITIONAL COMMENTS: Item No. 1 - Further investigation recommendedRemove tree on south side at stone wall

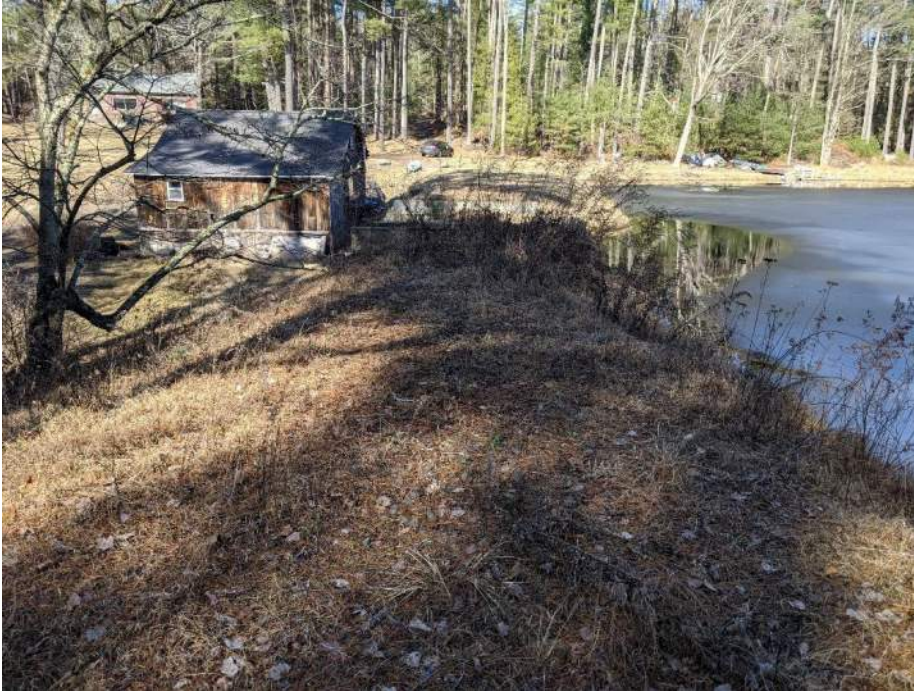
Photo No. 15

6. RUTS AND/OR PUDDLES	None	X		
	7. VEGETATION (PRESENCE/CONDITION)	well established - south side needs regular mowing		X	
ADDITIONAL COMMENTS: <u>South embankment (crest) is saturated - further investigation recommended</u> <div style="border-bottom: 1px solid black; height: 15px; margin-top: 5px;"></div> <div style="border-bottom: 1px solid black; height: 15px; margin-top: 5px;"></div> <div style="border-bottom: 1px solid black; height: 15px; margin-top: 5px;"></div>

Location:
South embankment crest

Subject:
Saturated embankment

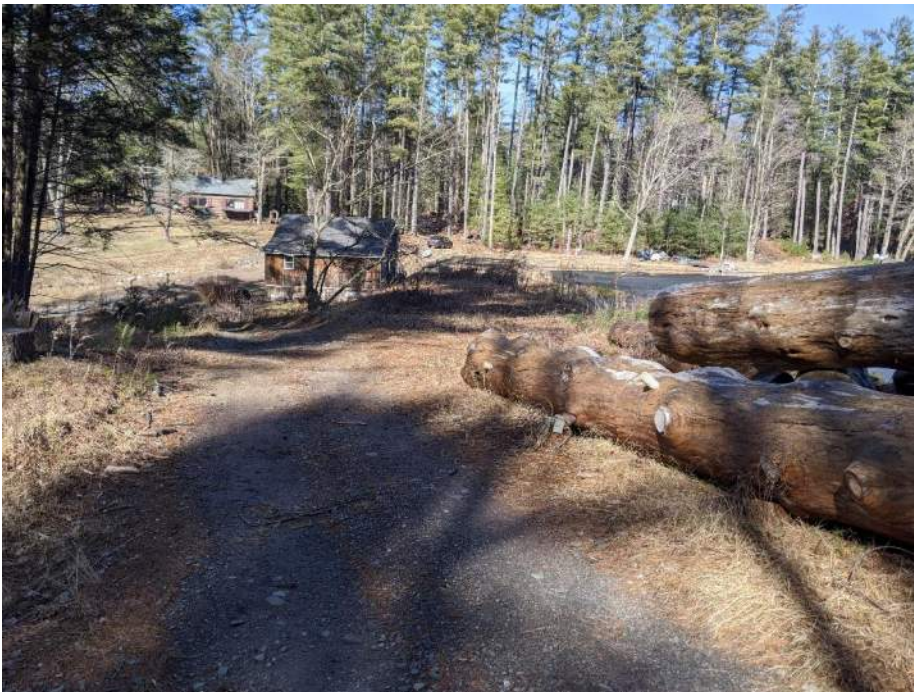
Photo No. 16

Location:
South embankment crest

Subject:
Nothing to prevent vehicle
access to embankment crest
