August 6, 2020

RE: Dam Inspection Summary  
Forestburgh Pond  
Town of Forestburgh  
Sullivan County, New York

FORESTBURGH POND  
 NYS ROUTE 42  
 TOWN OF FORESTBURGH NEW YORK STATE  
 SULLIVAN COUNTY  
 KEYSTONE PROJECT #0392.12119.1

DAM REPAIR  
 SKETCH

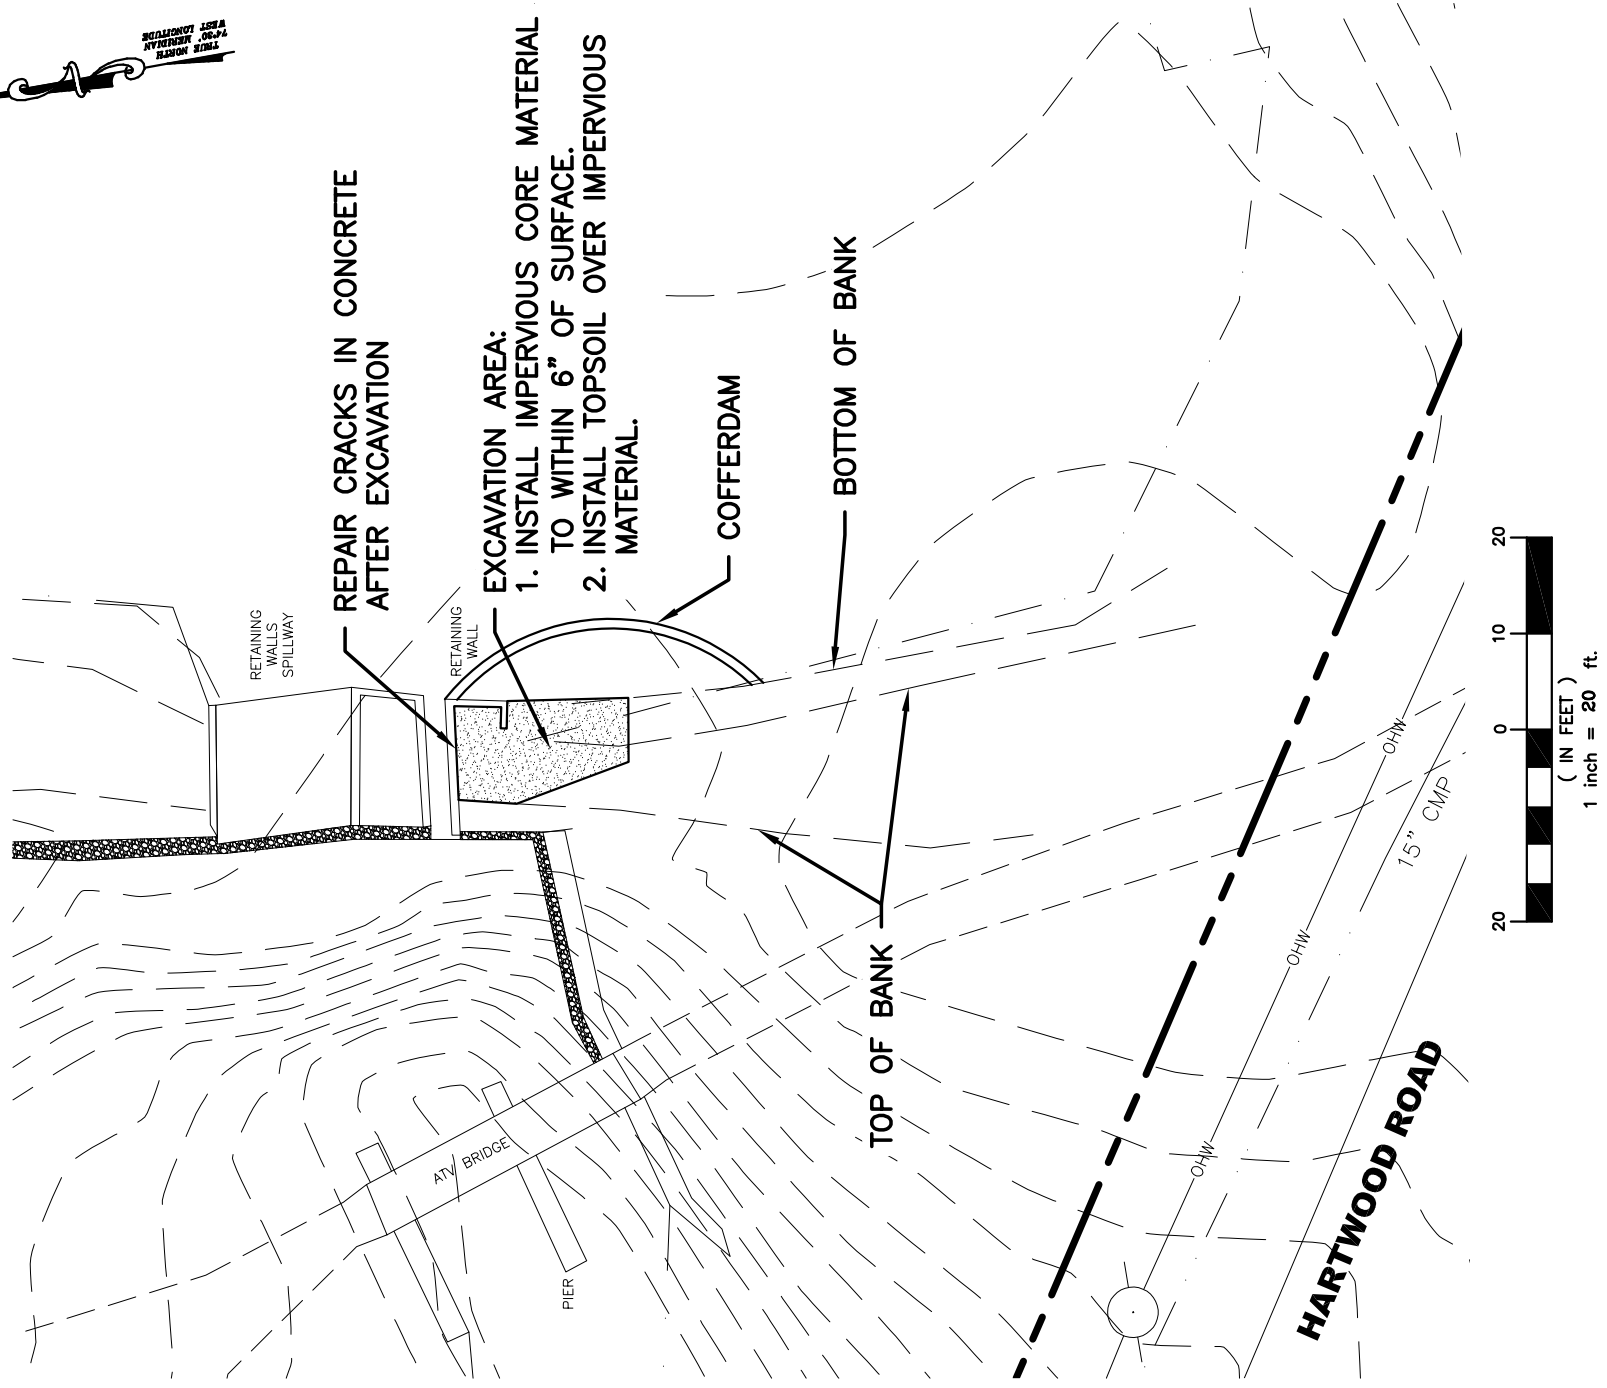
The most serious issues that were noted included the south embankment crest was saturated and a leak was observed in the low level outlet wall. It is our opinion that these two (2) conditions are related. We have prepared a draft repair sketch to address these conditions. In lieu of the cofferdam, the lake can be drawn down to allow the work to be completed. This would also allow for the low level drain weir boards to be replaced as the current boards are leaking.
